**ADDITIONAL SITE PHOTOGRAPHS TAKEN IN AUGUST 2021**

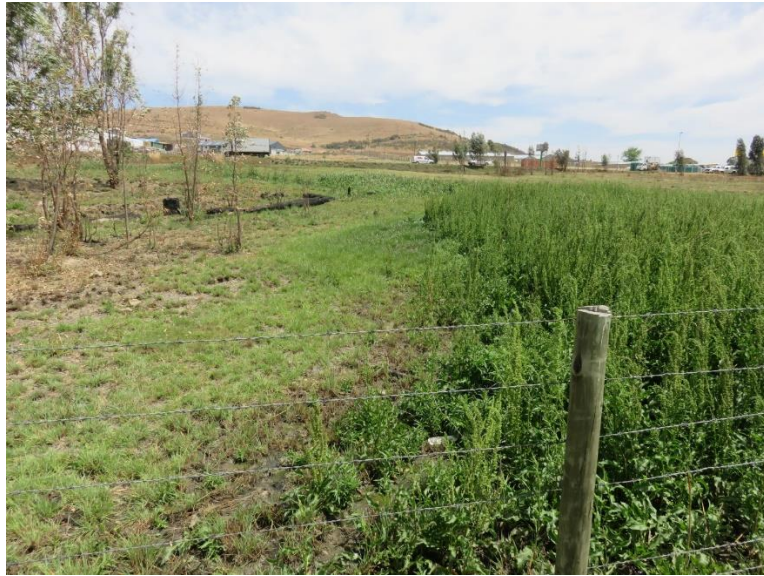
*Figure 1: Wetland observed within the 500m radius of the project site*

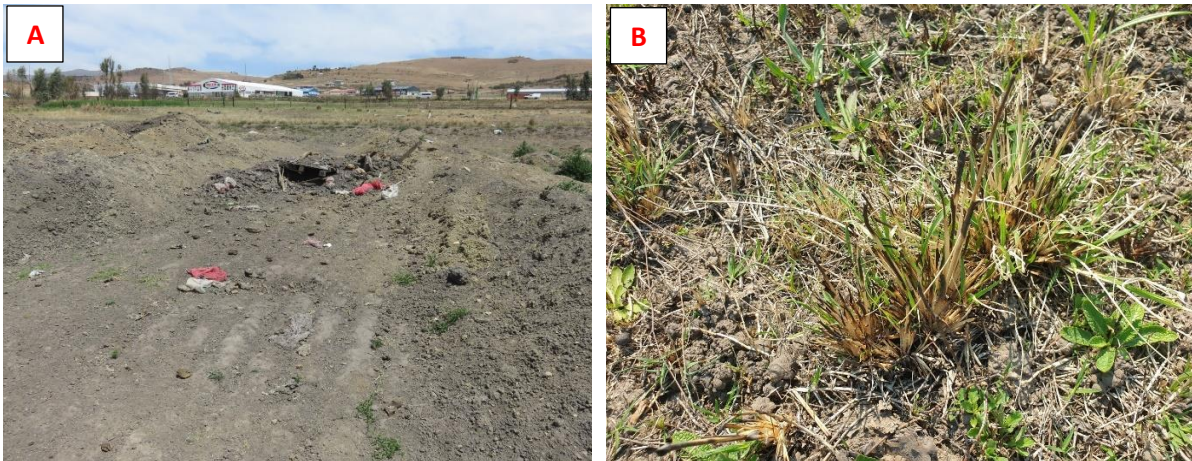
*Figure 2: (A) Dumping of soil and (B) burnt vegetative cover observed within the project site*

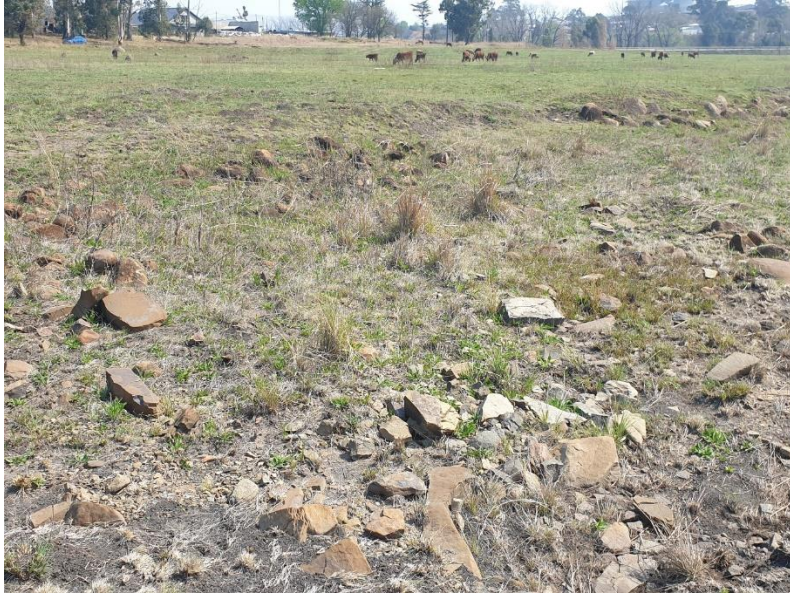
*Figure 3: Dolerite outcrop observed on the area where the culvert is proposed*

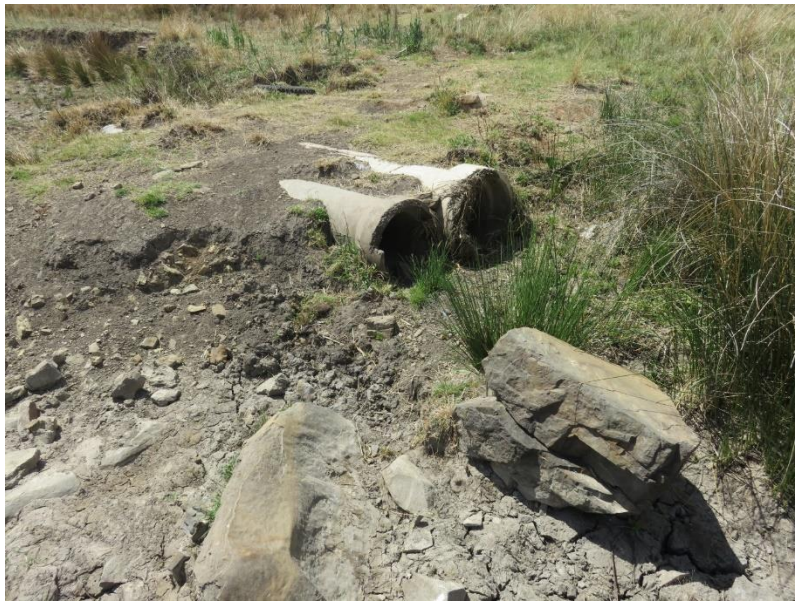
*Figure 4: Additional stormwater management infrastructure observed within the project site*
