**KOKSTAD ADDITIONAL WORKS
(Access Road and Culvert)
GEOTECHNICAL INVESTIGATION
REPORT**

AUGUST 2019

TERRATEST (PTY) LTD

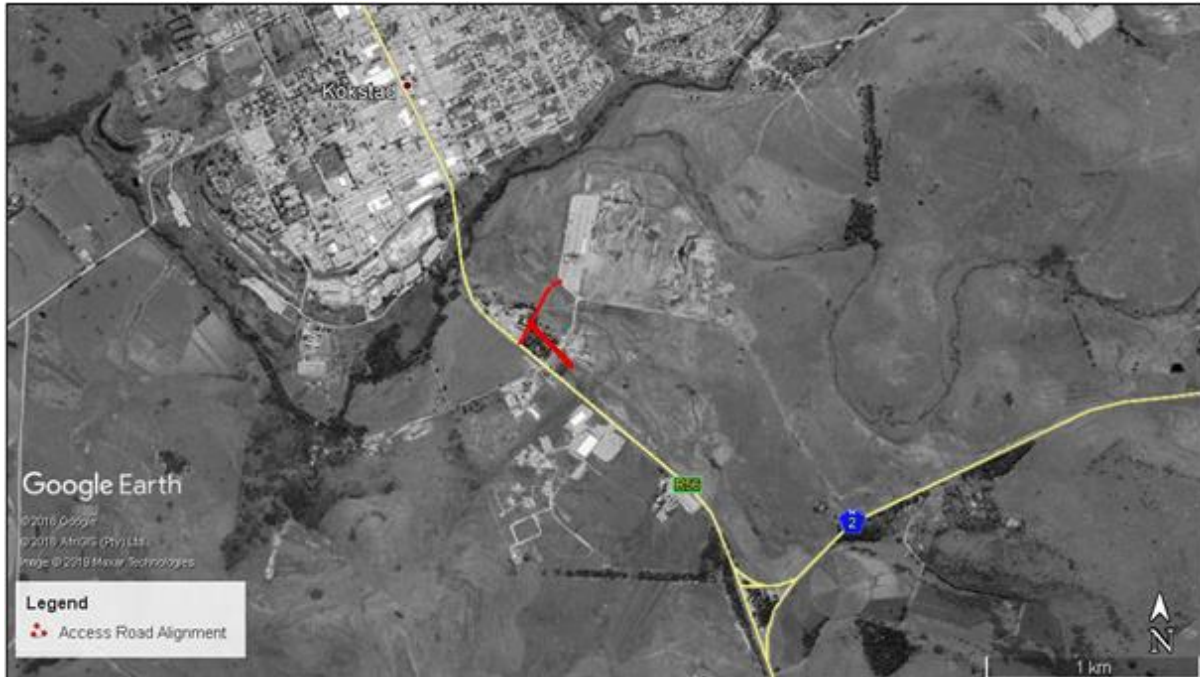
Figure 3-1: General Site Locality Plan and Access Road Alignment

These trees will need to be cleared to pave way for construction. A stream flows in a north westerly direction and crosses the proposed road alignment at chainage Km0+330. Figure 3-1 below shows the general location and alignment of the proposed access road in relation to the town of Kokstad and the surrounding environs.

The site is located off the R56 road into Kokstad and the proposed access road links the Trade Centre with the R56 road. The approximate length of the proposed access road is 383m and the alignment slopes gently in a north eastern direction towards the stream. At present, a large portion of the site is covered by short grass and a dense strand of eucalyptus trees between chainages Km0 and Km0+200.

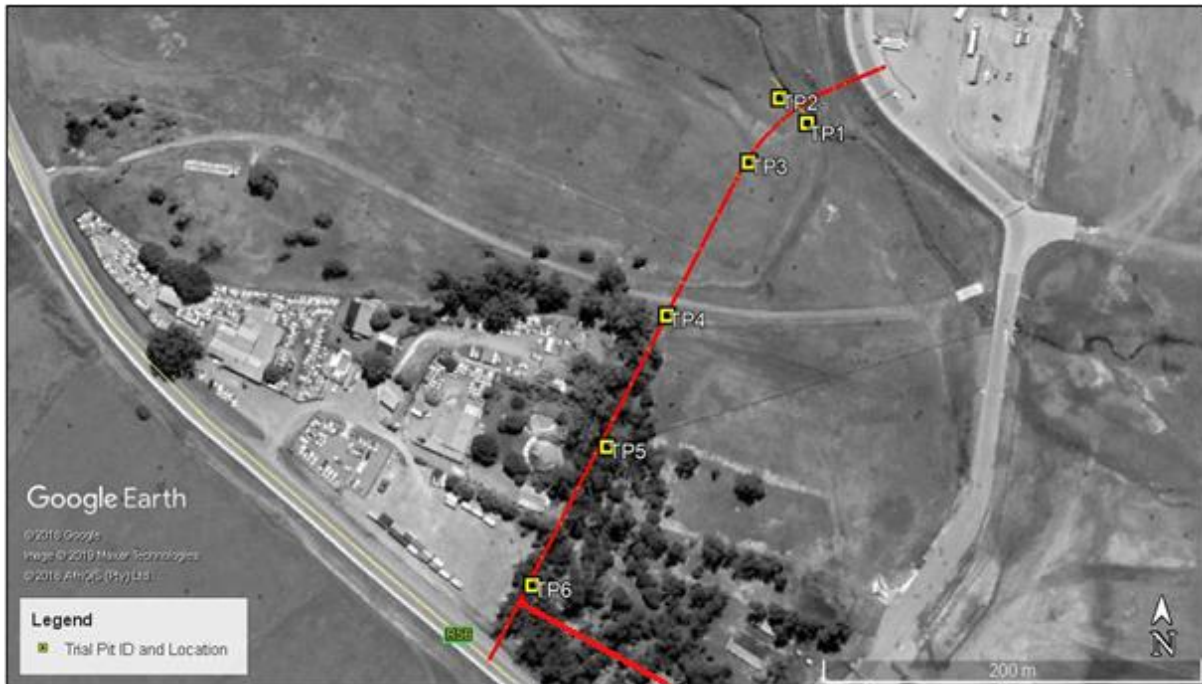
Figure 4-1: Trial Pit Plan

Six (6. No) trial pits presented in Table 4-1 below were excavated along the proposed access road centreline, the locations of which are indicated on the site plan, presented as Figure 4-1 overleaf.

- The mechanical excavation and profiling of six (6. No) trial pits labelled TP1 to TP6. TP1 and TP2 are at the culvert site while the remainder of the trial pits are located along the centreline of the proposed access road.

The positions of the trial pits are shown in Figure 4-1 in Section 4 of this report.
